Aviation Accident Review

FY04

Department of the Interior Aviation Accident Review

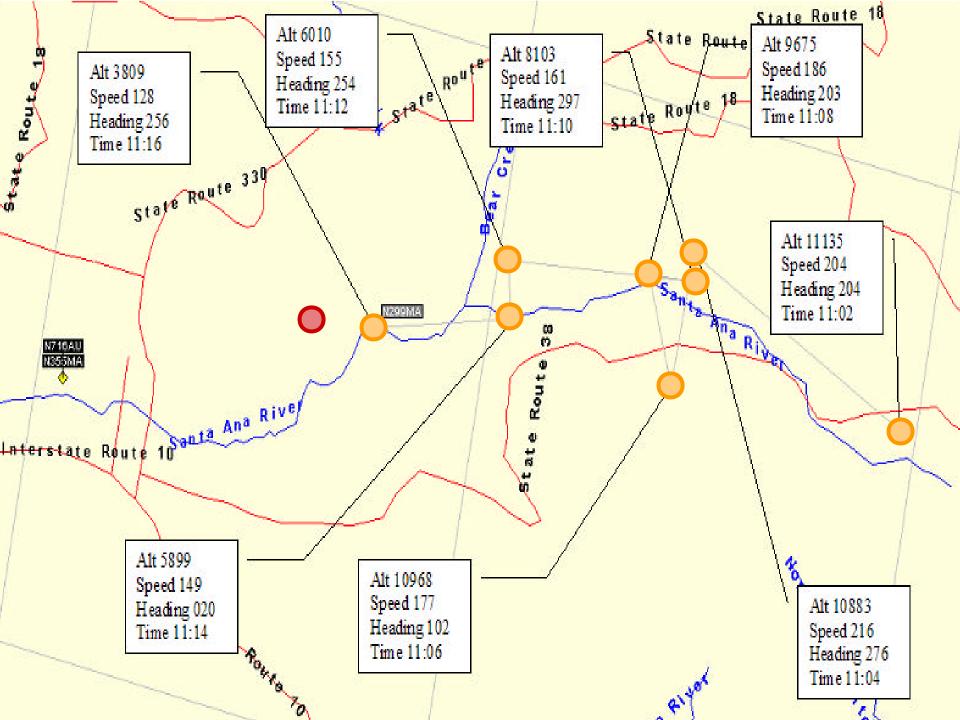
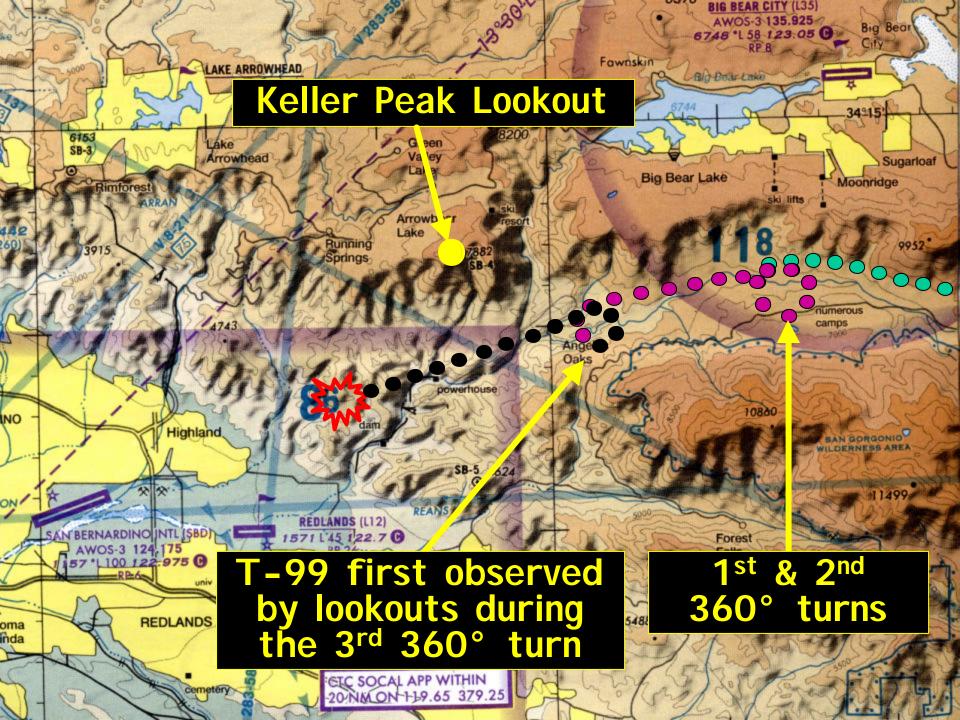
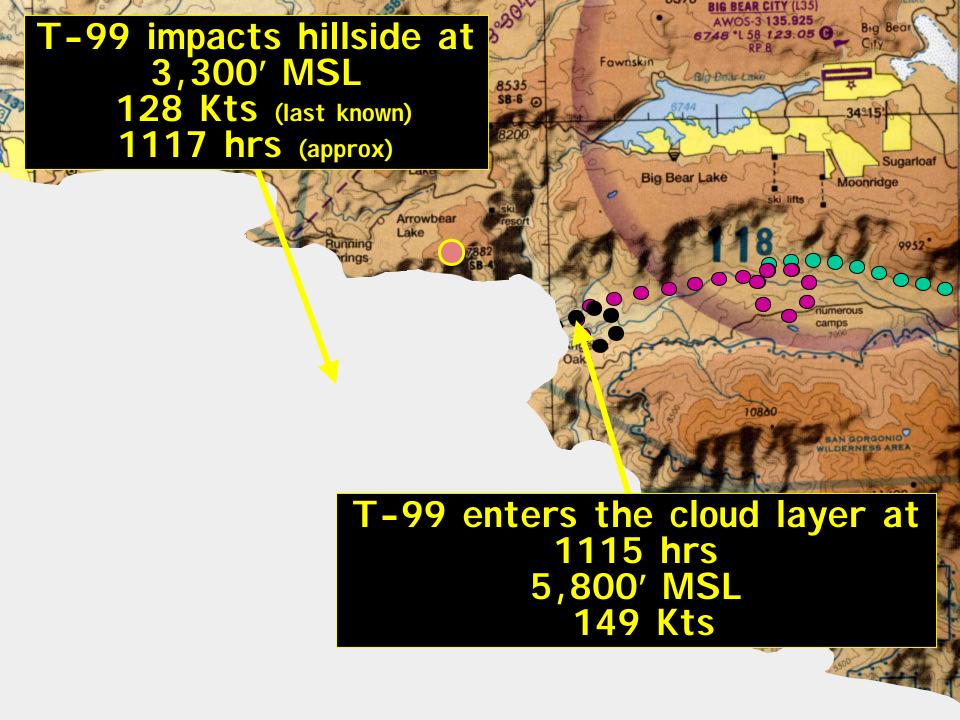
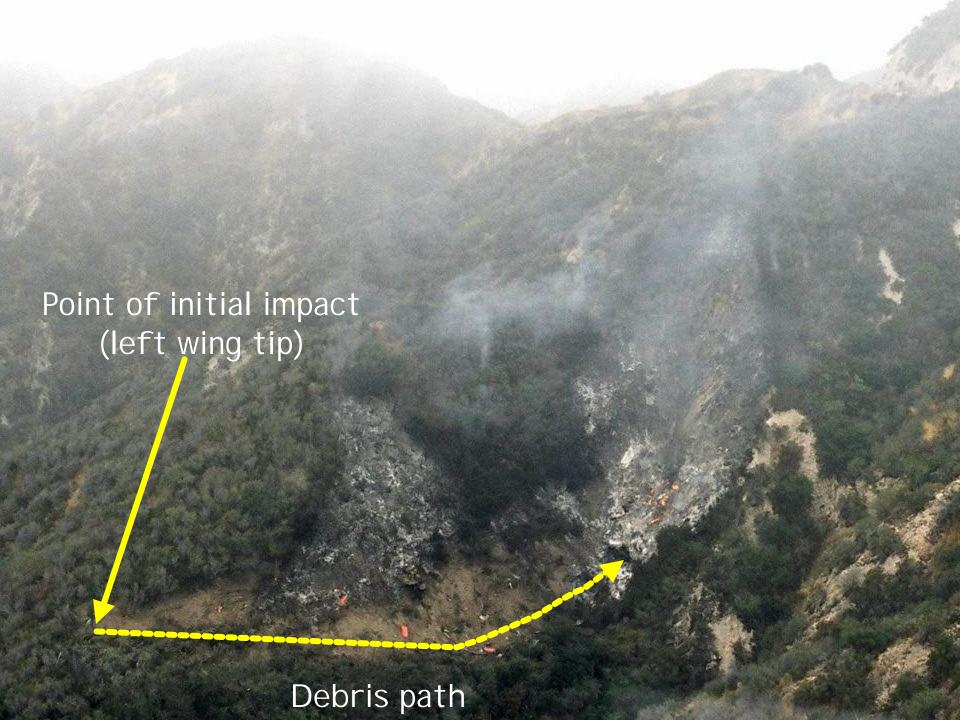
The P2V was observed flying up the Santa Ana Canyon from the southwest to the northeast. The aircraft made a 180° left turn, and descended into the clouds on a southwesterly heading towards the San Bernardino Airport / Air Tanker Base.

Moments after entering the clouds the witnesses observed a "rapidly rising dome" in the cloud deck.

The aircraft was destroyed when it impacted terrain.

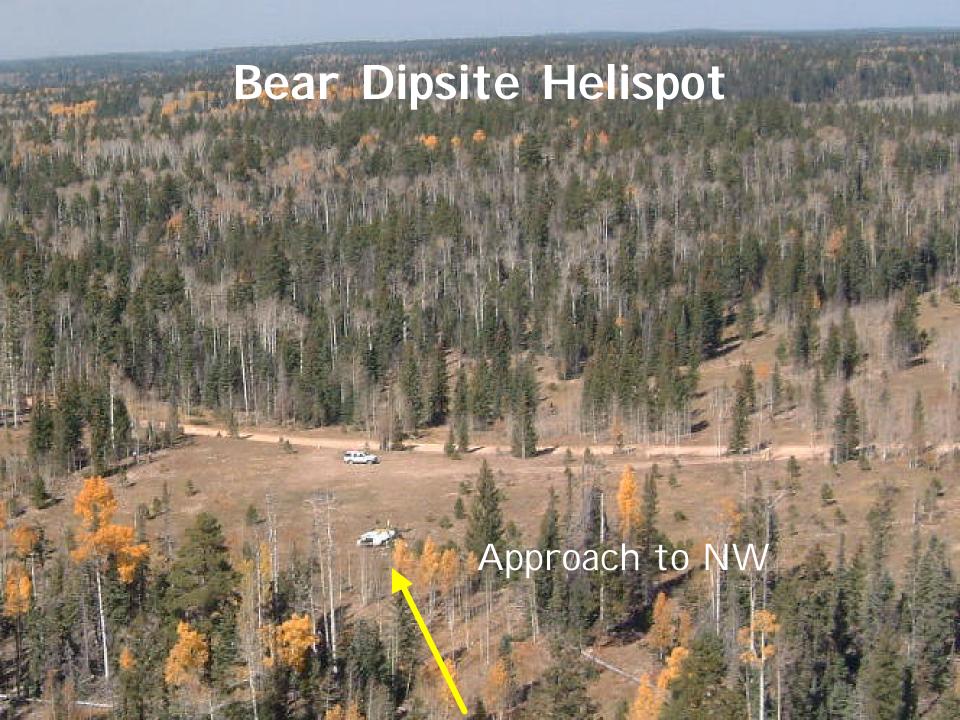
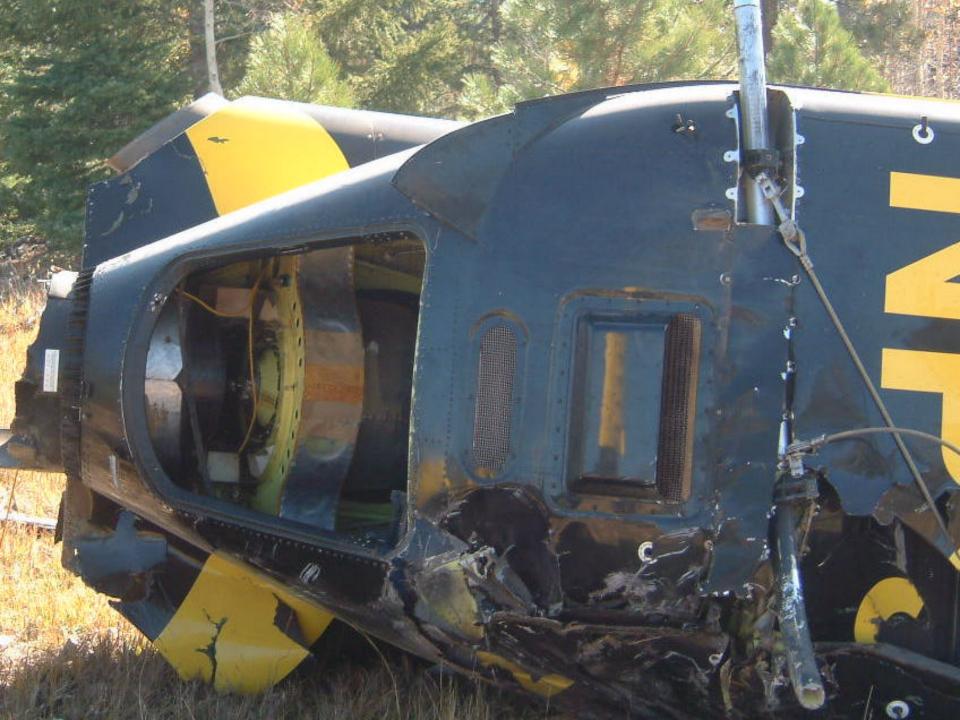
During approach to a helispot at approximately 40 feet above ground level and 10 knots the aircraft began a sudden uncommanded right yaw.

The pilot reported the pedals feeling unresponsive, as if they were disconnected.

The aircraft made several revolutions and impacted on its skids before coming to rest on its left side.

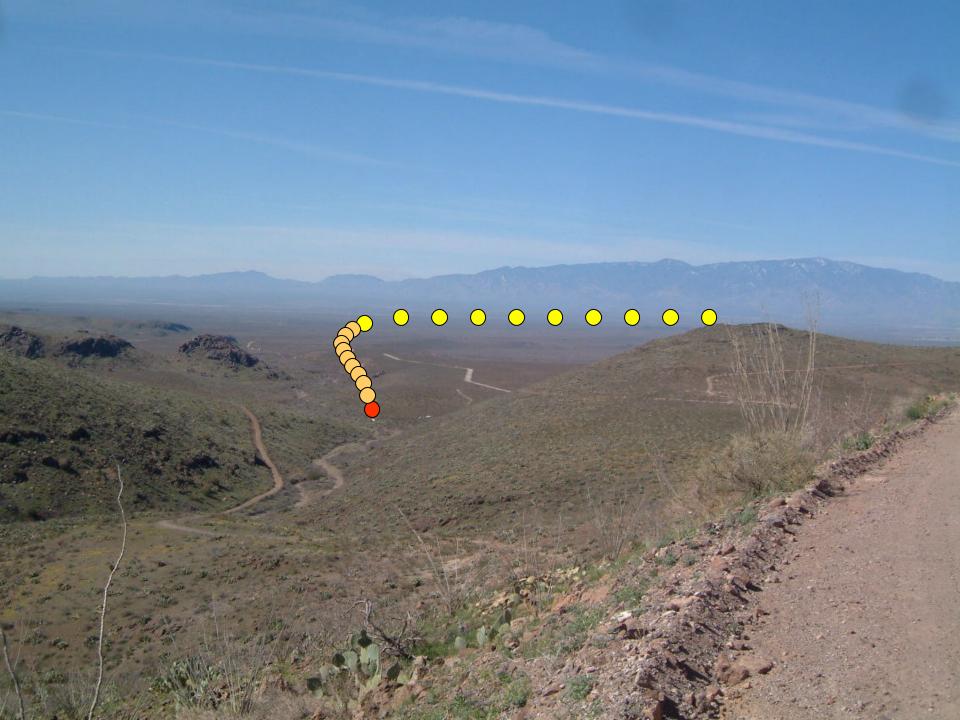
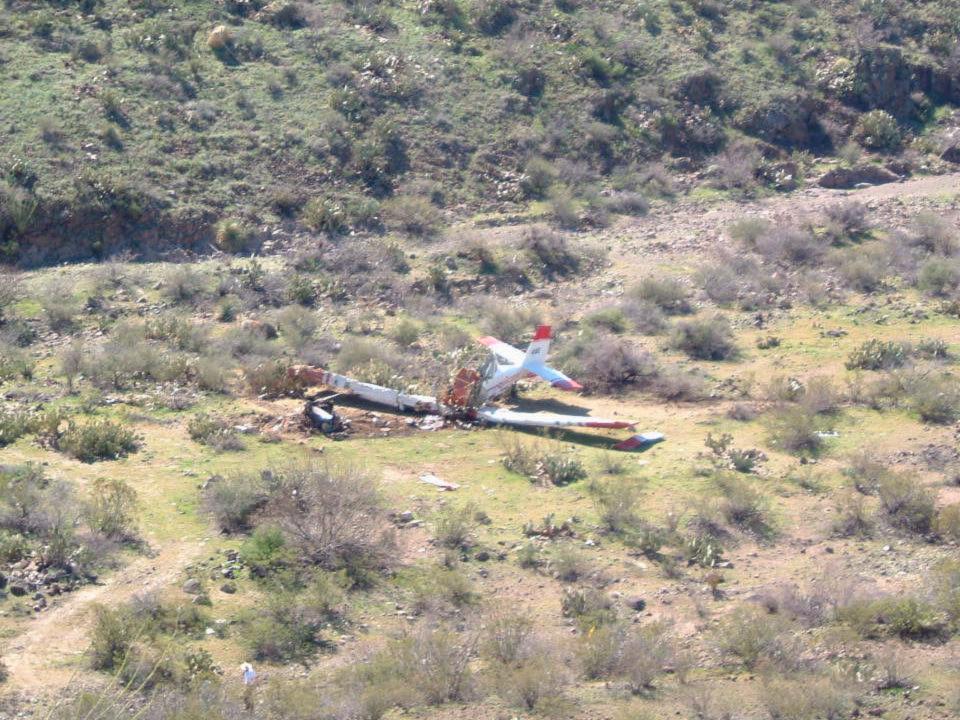
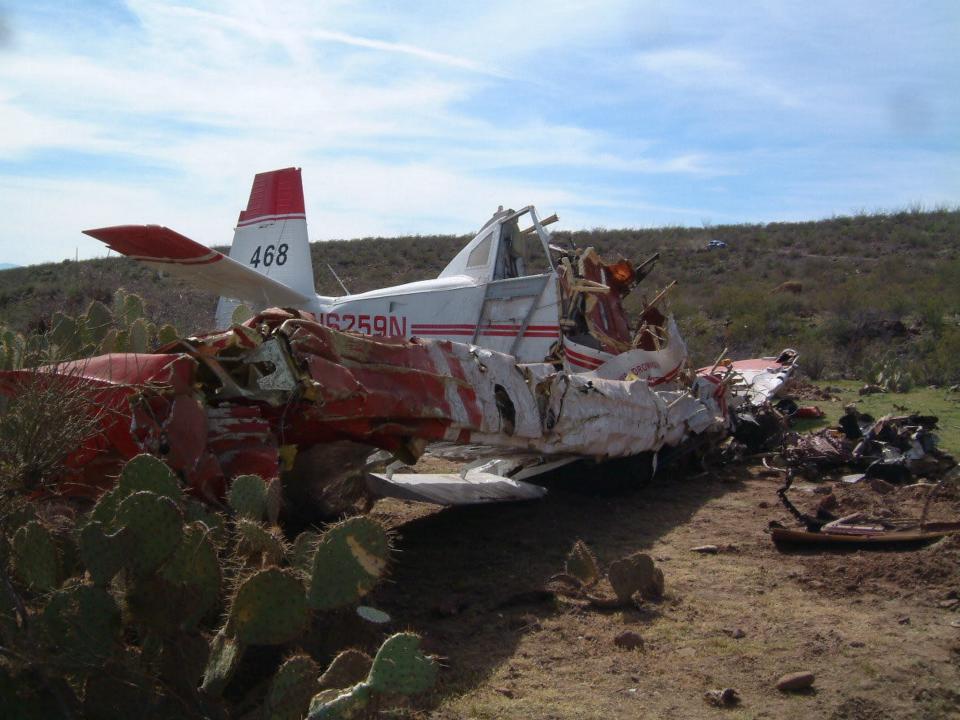
On the base leg to a simulated fire, witnesses heard the engine "surge" 2-3 times and observed the aircraft in an unusual attitude with its "right wing high and its nose low."

The evidence at the site indicates that the aircraft impacted the ground in a nearly vertical attitude.

The aircraft was destroyed and the pilot received fatal injuries.

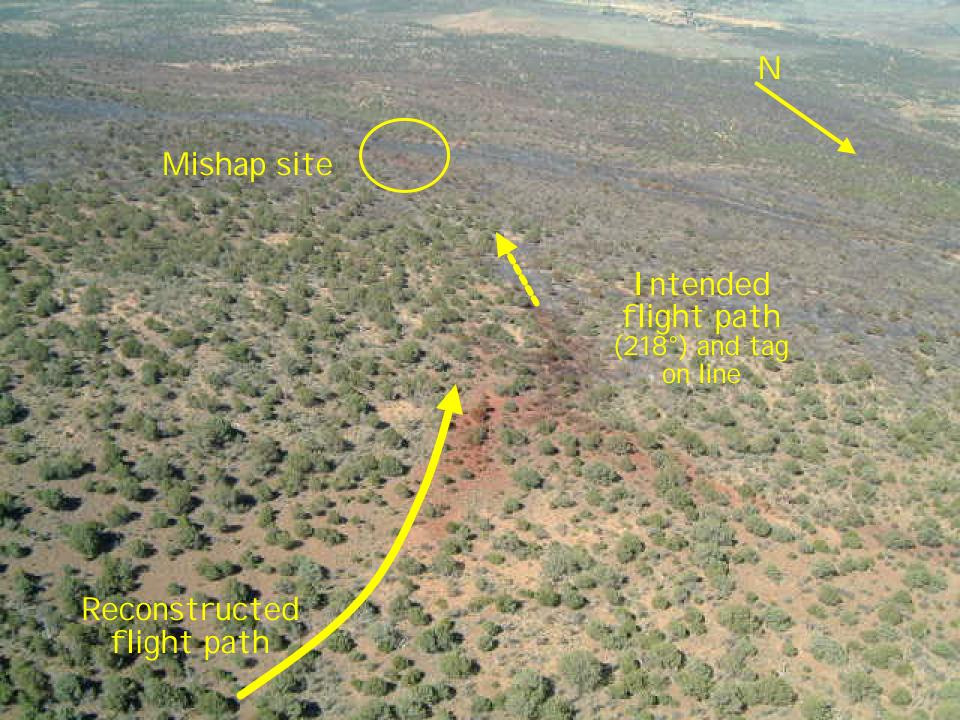
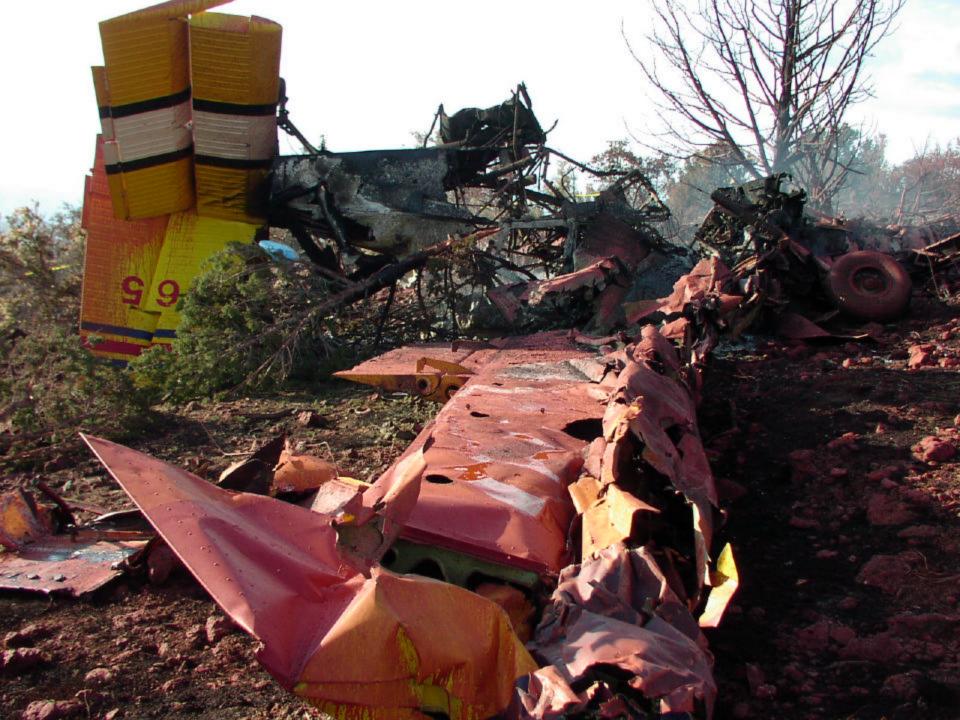
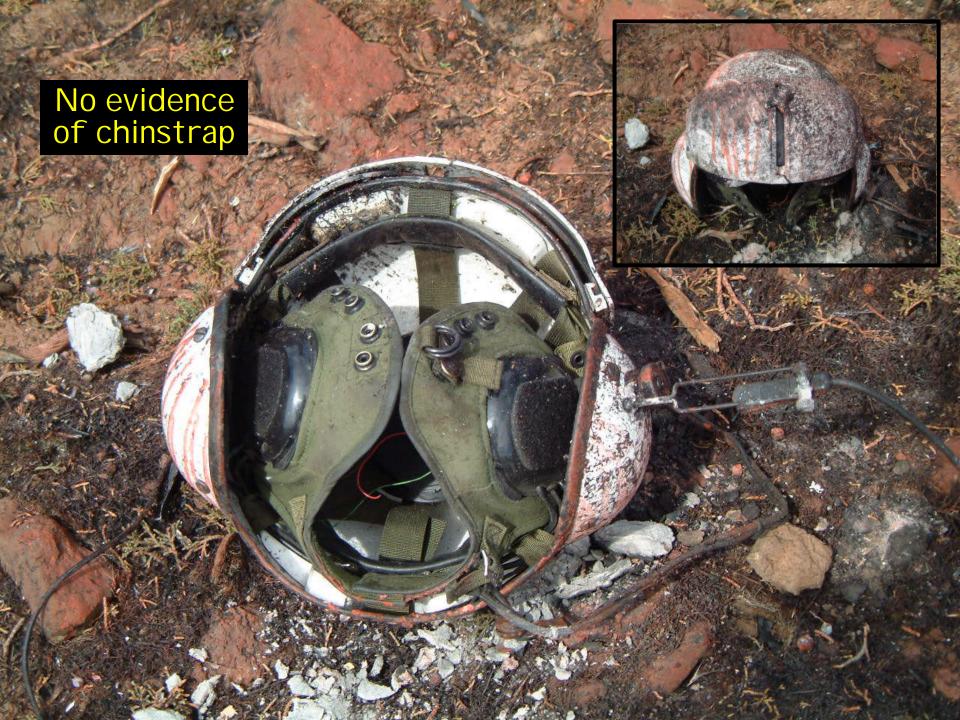
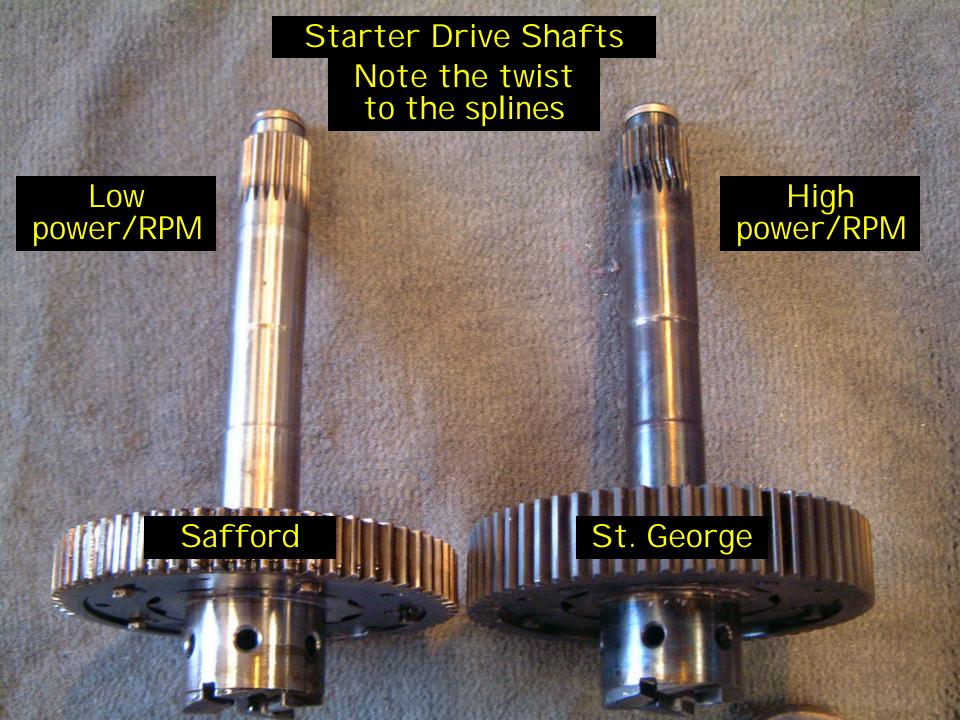
During a fire retardant mission the pilot was observed to make an early drop followed by the aircraft's nose pitching down approximately 45°.

The aircraft impacted the ground in a nearly vertical attitude and exploded.

The aircraft was destroyed and the pilot received fatal injuries.

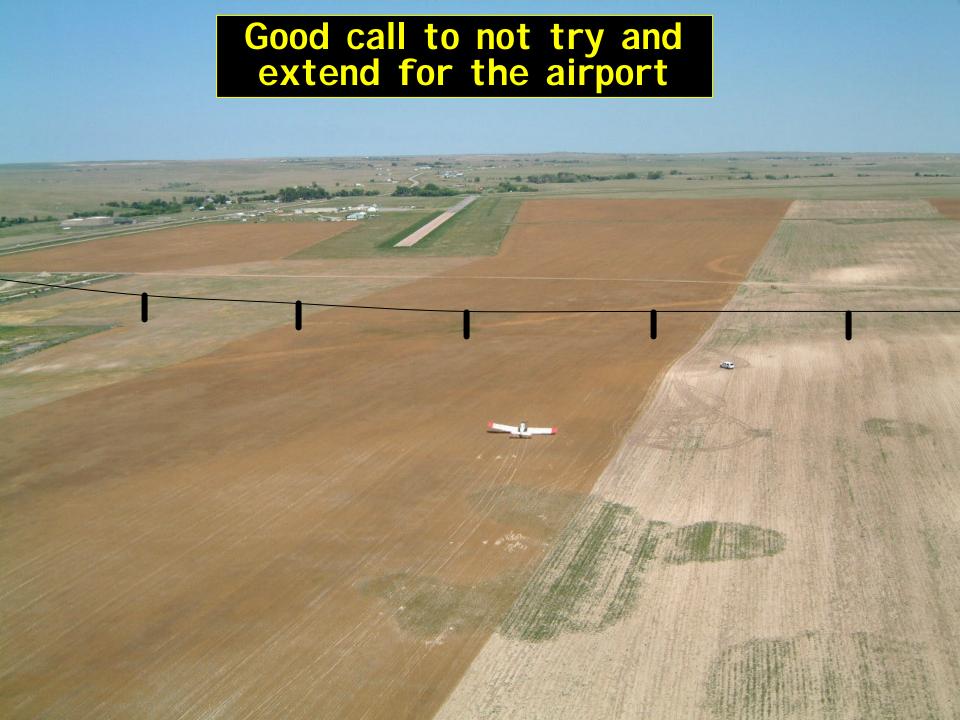
While preparing to enter the traffic pattern for landing, the pilot noticed the N2 (prop RPM) overspeed light illuminate.

The pilot tried, but was unable, to maintain prop RPM without the engine overspeeding.

The pilot reduced power to control the engine RPM and made an off-airport landing.

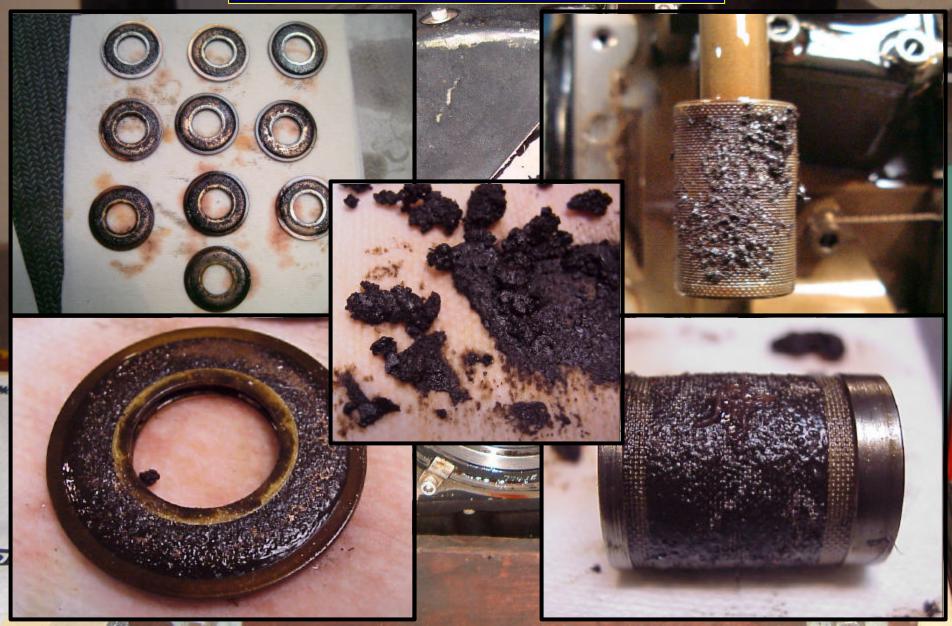
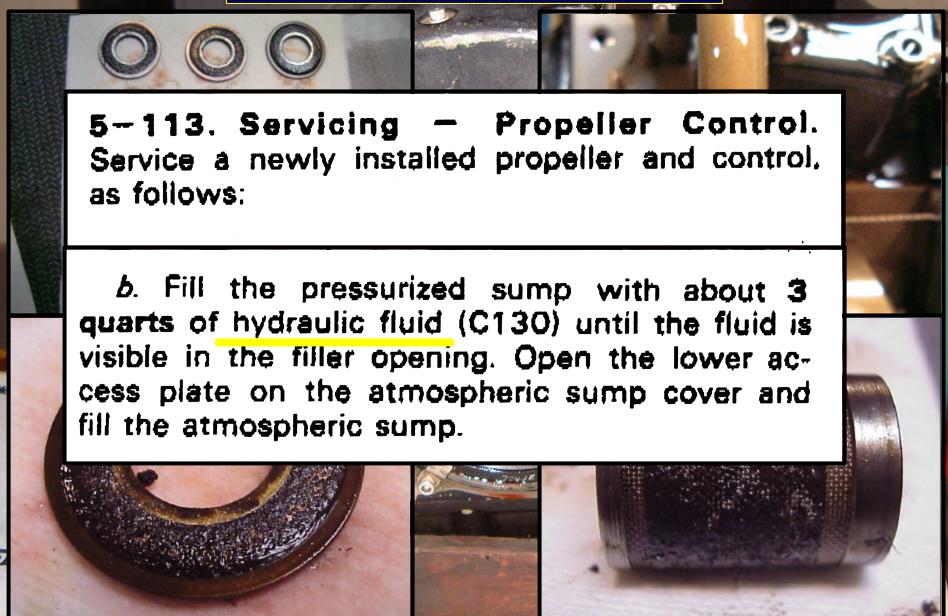
Gross contamination of filters led to prop lock

The propeller went to an overspeed condition as a result of contamination of the propeller control unit due to improper servicing by the operator and the mechanic.

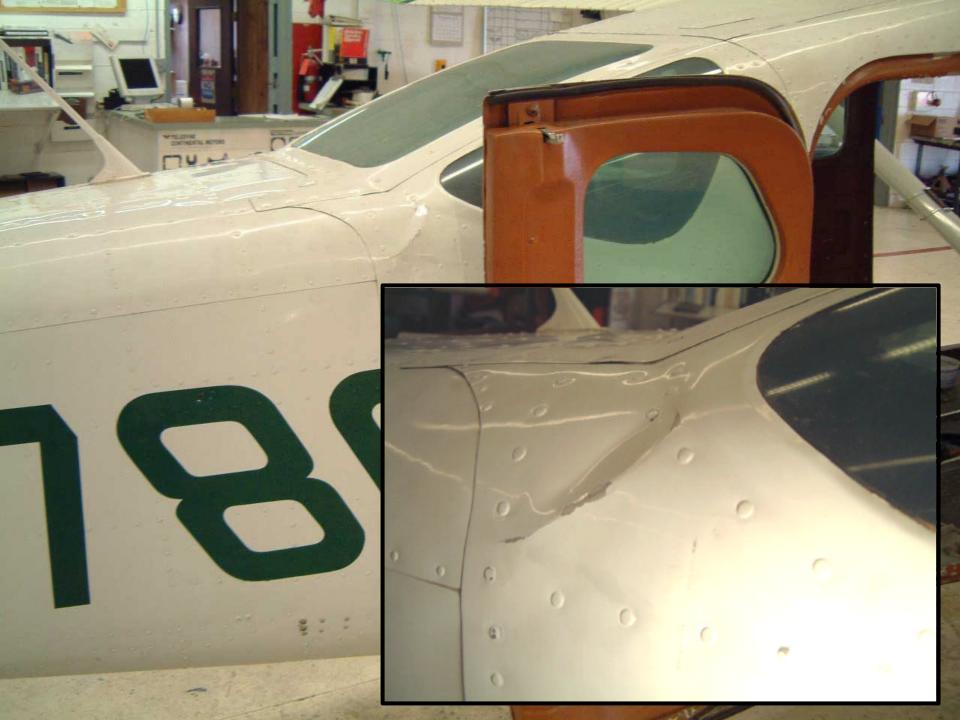
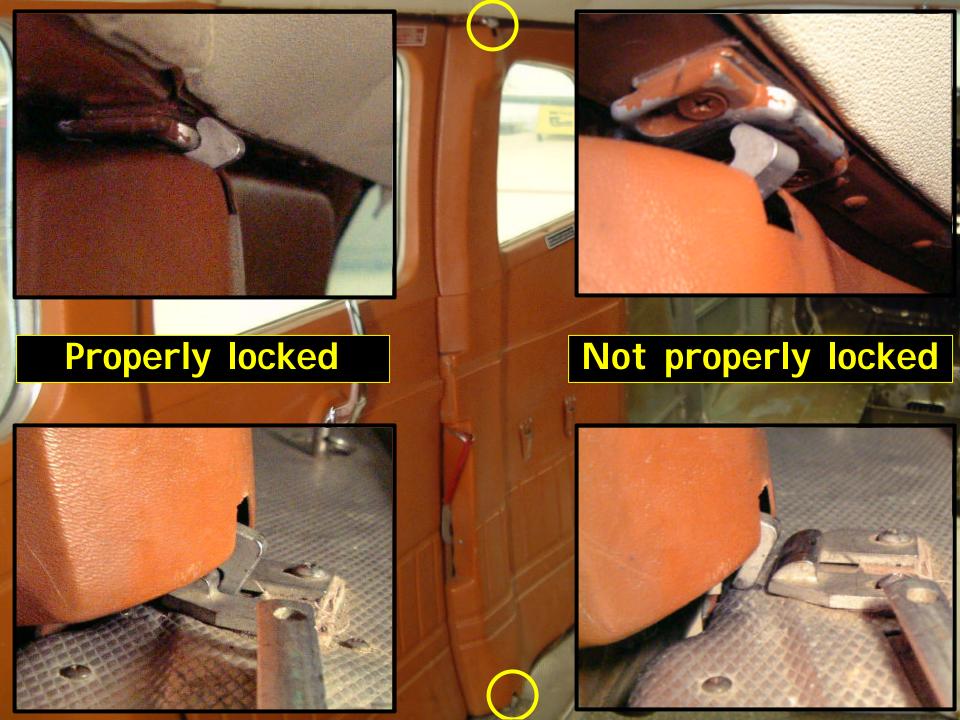
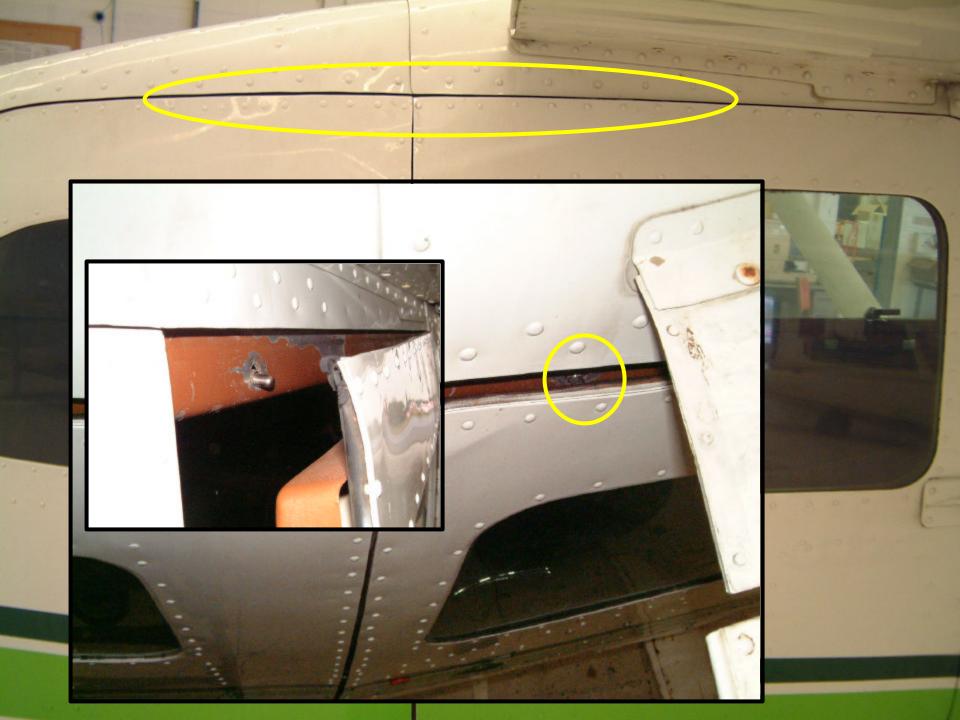
During the takeoff roll the aft cargo door opened and slammed into the fuselage.

The pilot aborted the takeoff, inspected the door for damage, and then resumed the flight.

The aircraft was flown several more times before the damage was reported via SAFECOM.

- The pilot's inadequate preflight inspection, and his failure to secure the cargo door, which resulted in the cargo door coming open during the takeoff roll.
